FINAL REPORT HILO BAY WATERSHED WATER QUALITY MONITORING PROGRAM

Hilo Bay Watershed Advisory Group Water Quality Monitoring Program

Final Report

Prepared by
Tom Young and Steve Godzsak
Primary Investigators

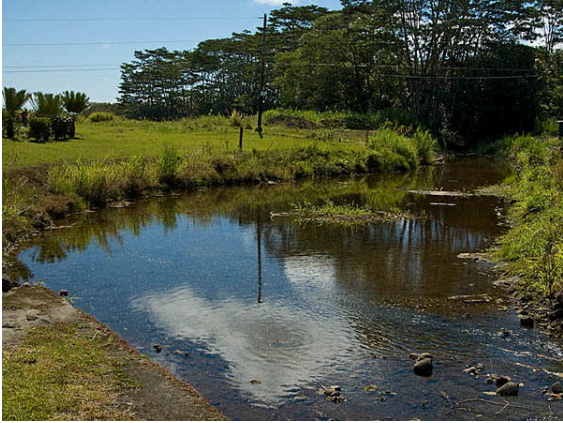
Waiakea Stream discharge area starts in the upper watershed near Mauna Loa. The stream starts close to Mountain View. The stream has ill defined

channels in the forested area. The stream is evident at Hoaka road south of Hilo. During protracted rainfall events or wet years flow is evident for less than a mile ending in a pasture above Kupulau Road. During the testing cycle we had flow in February stopping early in March continuing in mid March and continuing until May

19th when it dried up. The flow in February was at the tail end of a wet period and there was continuous flow in the entire reach for a few weeks. We were able to collect one set of samples for the entire reach. This stream is intermittent or ephemeral in the full reach but has more evidence of some flow (photo left) at Hoaka Road during normal rainfall patterns. During the collection process we saw some mosquito fish and dragon fly larvae. There was an absence of native aquatic biota along with a lack of the Tahitian prawn (*Macrobrachium* Lar). Storm events produce a different scenario. During protracted storm events this dry stream becomes a raging torrent that does not respect any boundaries. The last flooding event in 2008 provides a different picture of this stream. Areas that have not been protected or hardened experienced extensive flooding. Prolonged intense rainfall on the first and second of November, 2000 brought a new dimension to flooding and erosion for this area. Rainfall was concentrated in Waiakea with totals of 32.47 inches recorded. Combined damages in excess of 70 million dollars for Kapapala and Waiakea were recorded. At Hoaka Road stream flow was braided and overflowed the road washing a house off its foundation and onto the road. At Kawaihine Street the Waiakea Stream caused extensive damage resulting in requiring a new bridge to be built along with extensive stream channel hardening. It should be noted that the Federal Flood Insurance Maps had to be redrawn on account of this event.

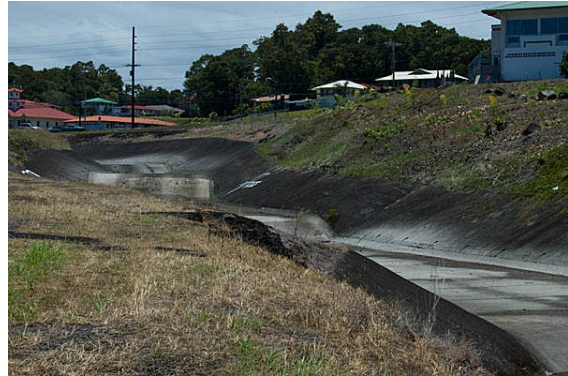
The Waiakea Stream in its lower reach is a modified storm water channel. The channel between Komohana and Kinoole streets has steep cut sides and a rocky bottom lacking in adequate habitat. Between Kinoole and Kilauea the entire channel has been hardened with concrete (photo

right). This reach is a concrete storm channel that ends at the beginning of the tidally influenced Waiakea pond and recreational area. The hardened channel has relief holes in the sides and face that allow the spring that is evident to discharge into the Waiakea Estuary.

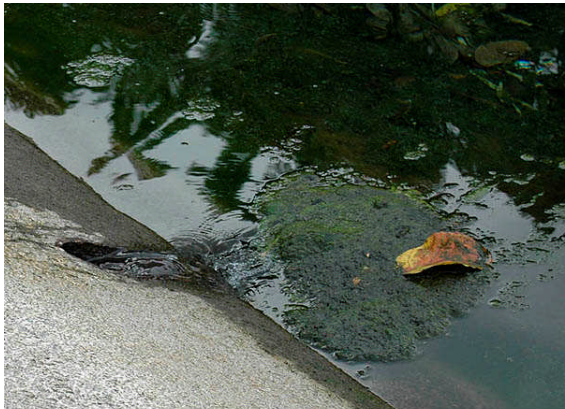
Wailoa Pond pipe flow

There are at least twenty five inch pipes that discharge along each side, a 16 inch pipe, plus several five inch pipes on the face of the last drop of the hardened channel bottom. The flow from the spring at low tide creates a fast flowing channel along one side of the gravel deposited from the last storm. It is evident from observation of the aquatic life that the species are

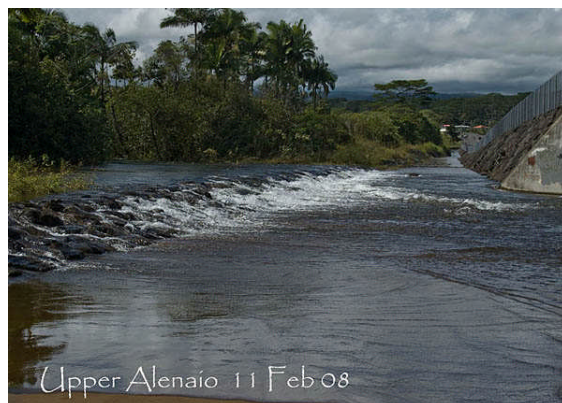
The Alenaio Stream is part of a larger system that starts high in the watershed near Saddle Road and borders the Wailuku River Watershed on the west side and the Waiakea Watershed in the east. There are three streams that converge to create the flow that will enter the Waiolama Sanitary Canal and eventually the

Waiakea Pond. The Waipahoehoe Stream joins with the Kaluiki branch and an un-named stream below Akolea Road to form the headwaters of the Alenaio Stream. This stream crosses Kaumana Drive at Chong's Bridge. The stream at this point is mostly perennial from Wilder Road past Akolea Road under Chong's bridge and at some point north of the bridge it goes underground and becomes intermittent or ephemeral. The Alenaio Stream, according to conventional thought, starts at Moohouli Bridge (photo above) and continues north in a natural channel then enters an improved concrete channel under the Komohana Street Bridge through an extremely eroded stream channel until it reaches Kapiolani Street. At this point the channel becomes a concrete lined storm control channel that empties into Waiolama Spring and Waiolama Sanitary Canal. This stone lined channel was part of an attempt to drain the Waiolama River Complex after the area was filled in with dredge and fill material during the railroad construction and related projects around 1910 by the Territorial government. During extreme flooding conditions the flow

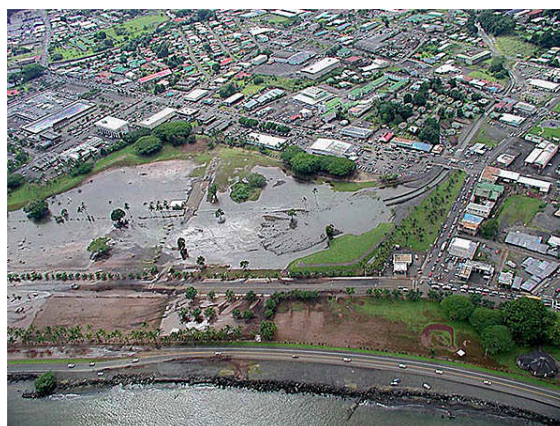
will overcome the channel capacity and overflow onto a soccer field, cross the road, and enter the bay as the aerial view (photo right) of the November 2000 event demonstrates.

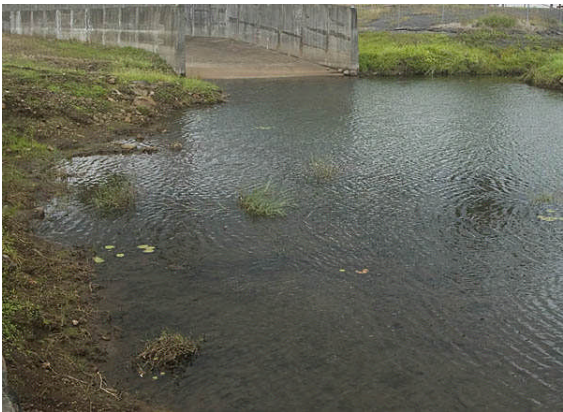
Waiolama Spring area at the end of the Alenaio Storm Channel

The Waiolama Spring supplies water to the Waiolama Sanitary Canal beginning at the end of the dry Alenaio concrete channel (photo left). The Waiolama Spring is the only evidence of the Waiolama River and fish ponds that were covered up during and after the construction and dredge and fill of the railroad and improvements to the

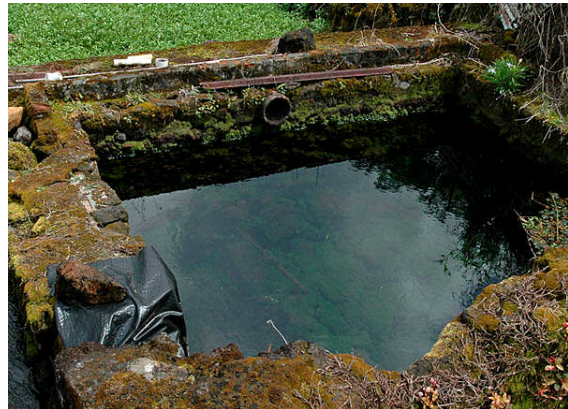
Wainuenu Avenue and ultimately enters the Wailuku River above Carvalho Park. Kaumana Spring (photo right) was one of the oldest developed water sources that provided drinking water to the town of Hilo. At some time in the mid 1960s the Department of Health closed off this water source because of contamination due to the build out of homes above the springs. The State of Hawaii Department of Land and Natural Resources Division of Water and Land Development (DOWALD) produced an inventory of Basic Water Resources Data: Island of Hawaii February 1970 Report R34. The following is an excerpt of that data. This data summarizes the nutrient constituents for Kaumana Springs for the periods listed.

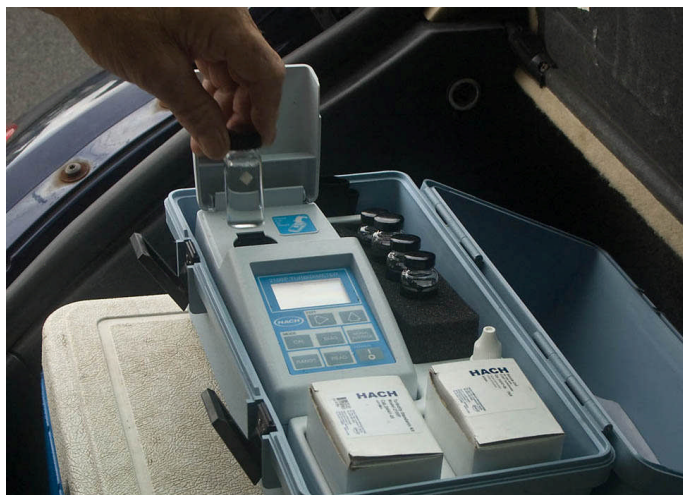
Placing sample in turbidity meter

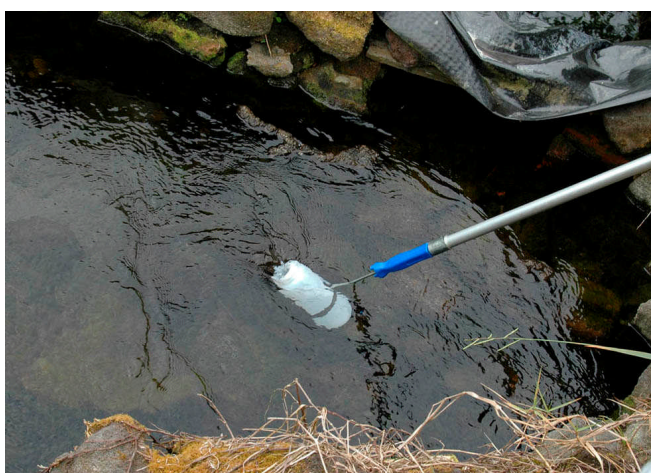
Sampling Kaumana Spring

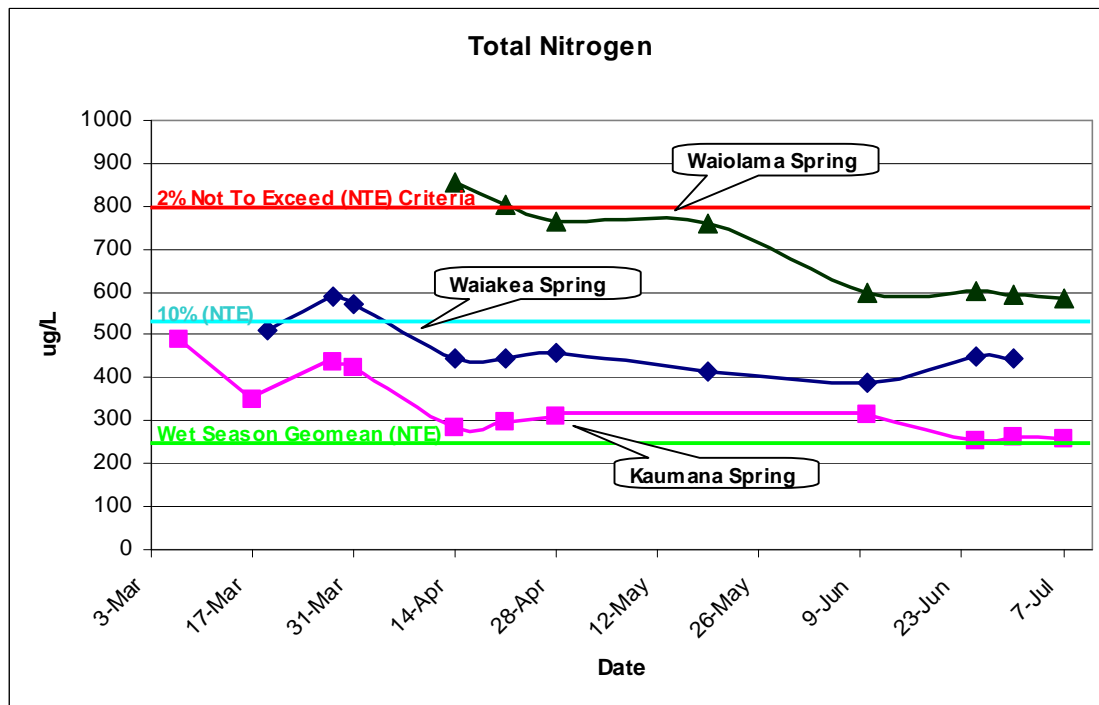
Figure 3. Total Nitrogen found in springs

Total Nitrogen(TN) was measured at each site 6-8 times, except on the lower Waiakea and upper and lower Alenaio, where only one sample each was recorded. Those sites with elevated levels of Nitrogen are Waiakea Spring, Kaumana Spring, and Waiolama Spring. The actual measured levels for these specific sites are shown in the attached graph.

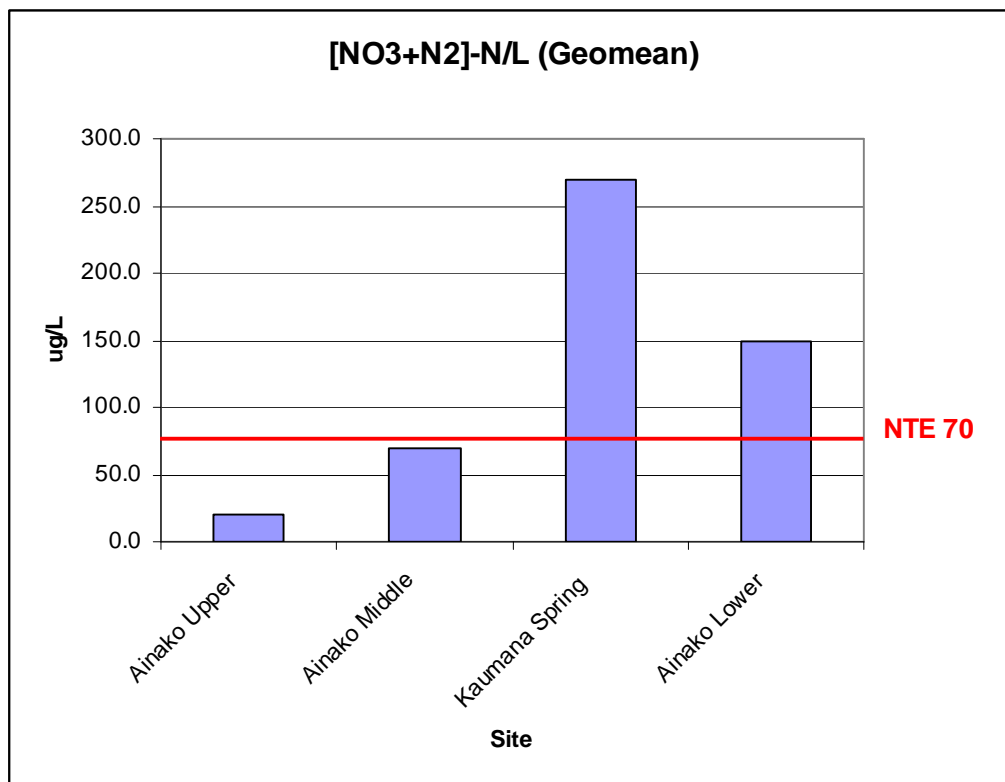
The Waiakea, Kaumana, and Waiolama Springs all had elevated levels of nitrate + nitrite. The upper Kaluiki Branch of the Waipahoehoe Stream (at Akolea Road) and the lower Waipahoehoe Stream (at Chong’s Bridge) had elevated levels of nitrates and nitrites. It seems that the springs contribute to higher levels of nitrate and nitrite to the down stream waters.

Figure 4. Geomean of organic levels found in Ainako Stream
Note: Not To Exceed (NTE) criteria level from State water quality standard

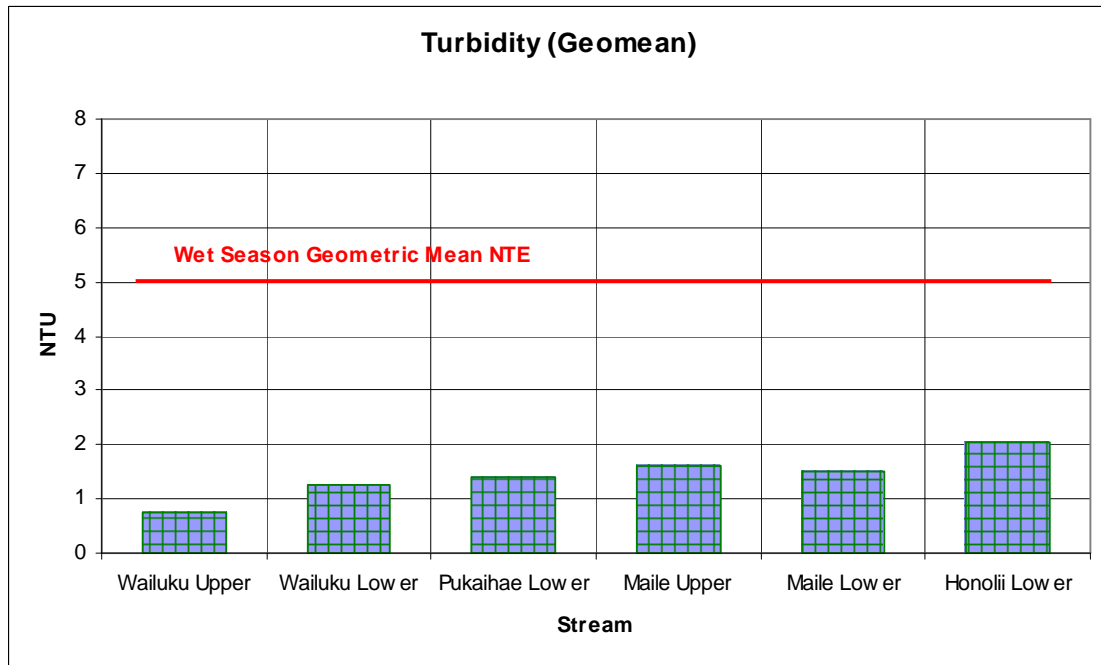
Figure 5. Stream turbidity

The total number of turbidity samples taken across all sites was 113 with an overall geometric mean of 0.70 NTU. This represents a very low overall turbidity in light of the samples being taken primarily during the wet season. The six sites with the highest turbidity levels are shown with their corresponding geometric mean in Figure 5. The highest single measurement was 6.26 NTU on the lower Honoli'i stream. The following chart compares turbidity at the upper and lower reaches of the Wailuku and Maile streams and also with the lower Pukaihae and Honolii. Access to the upper reaches of the Pukaihae and Honolii was not possible.

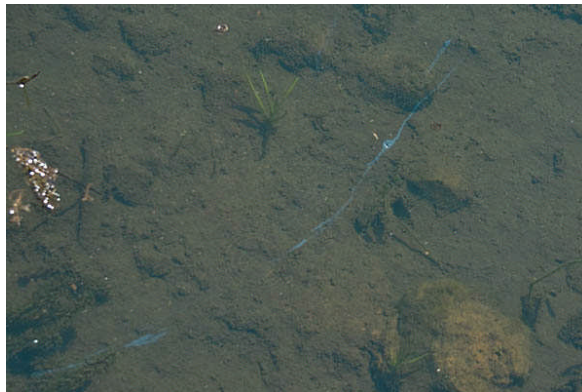
There were also incidents of poor water clarity noted, trash, and floating debris, particularly at Waiolama Spring. Photo at right shows a film floating on the surface that appears to be oil. Turbidity was 0.97 NTU on June 30, 2008, the day this film was observed.

The Hilo Bay Watershed Advisory Group recommends further studies be funded and field work undertaken to determine the sources of for high nutrient levels in the Waiolama Spring, Kaumana Spring, and the Waiakea Spring. The study should include flow information and brackish properties of the waters. The study might include taking samples from springs outside of the urban environment for comparison purposes. Furthermore, a study into the causes for stream turbidity under non-storm conditions and monitoring of stream bank erosion should be performed.

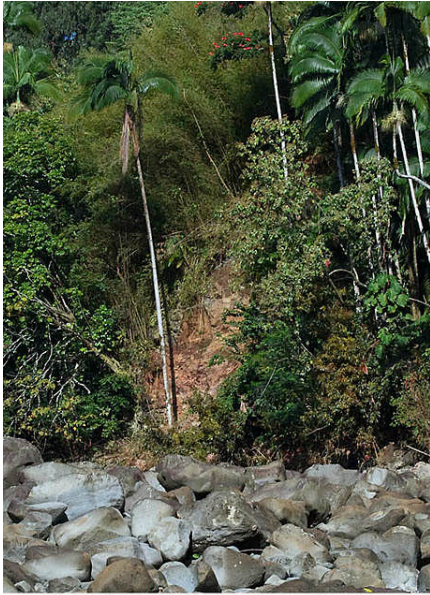
During the course of collecting samples, a number of eroded areas along the Wailuku and Honoli'i stream banks were noted. This natural erosion is likely one of the primary causes for the elevated turbidity (brown color) seen during high rainfall events. When the erosion occurred is unknown.

Erosion in Wailuku stream bank

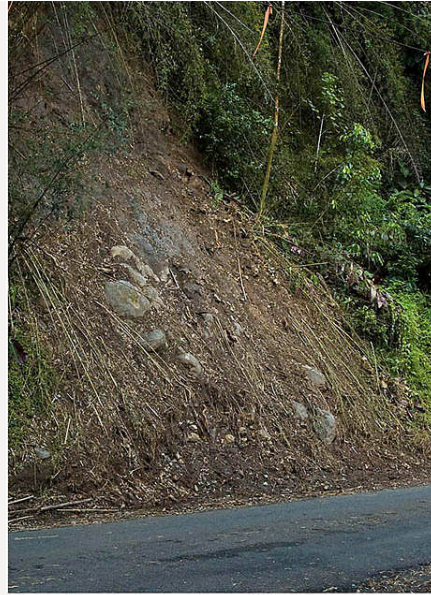
Erosion near Honolii bridge
